Engineering Solid Mechanics

Restoration of tensile properties in cracked aluminum specimens via composite patching**Touam Lakhemissi^a, Rebai Billel^{a*}, Derfouf Semcheddine^{b,c} and Messas Tidjani^a**^aFaculty of Sciences & Technology, Civil Eng Department, University Abbes Laghrour Khenchela, Algeria^bFaculty of Technological Sciences, University of Batna 2, 05078 Batna, Algeria^cLGM Mechanical Engineering Laboratory Biskra University, BP 145, Biskra 07000, Algeria**ARTICLE INFO***Article history:*

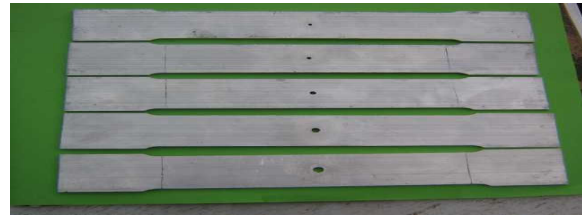
Fig. 2. Specimens pierced with diameters (1-2-3-4) mm

- Uncracked Samples: These are used to determine the baseline mechanical properties of the aluminum material.
- Cracked Samples: Holes of 2 mm, 3 mm, and 4 mm in diameter have been drilled in the center of the samples to artificially induce cracks. This is depicted in **Fig. 1** and **Fig. 2**.
- Repaired Samples: Cracked samples have been repaired by bonding composite patches over the holes. The patches are made of fiberglass fabric or mat in 4-ply laminates.

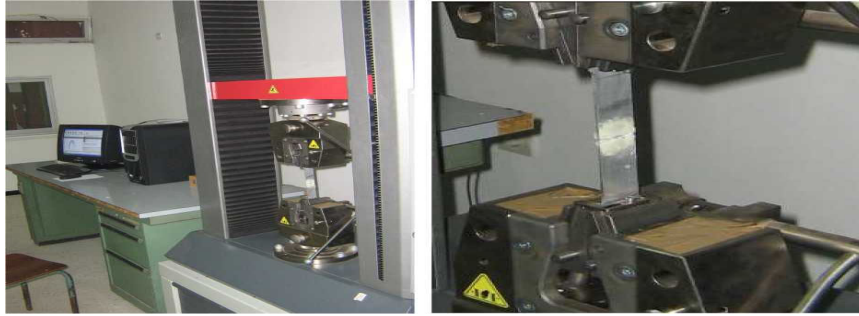
Fig. 5. View of the Specimen Positioned Between the Machine's jaws

Fig. 5 shows a specimen mounted in the testing apparatus. Tensile testing is being performed on samples of each type. Mechanical properties, including strength, breaking force, and deformation, are being measured. Stress-strain curves are being generated for analysis and comparison of the different sample conditions.

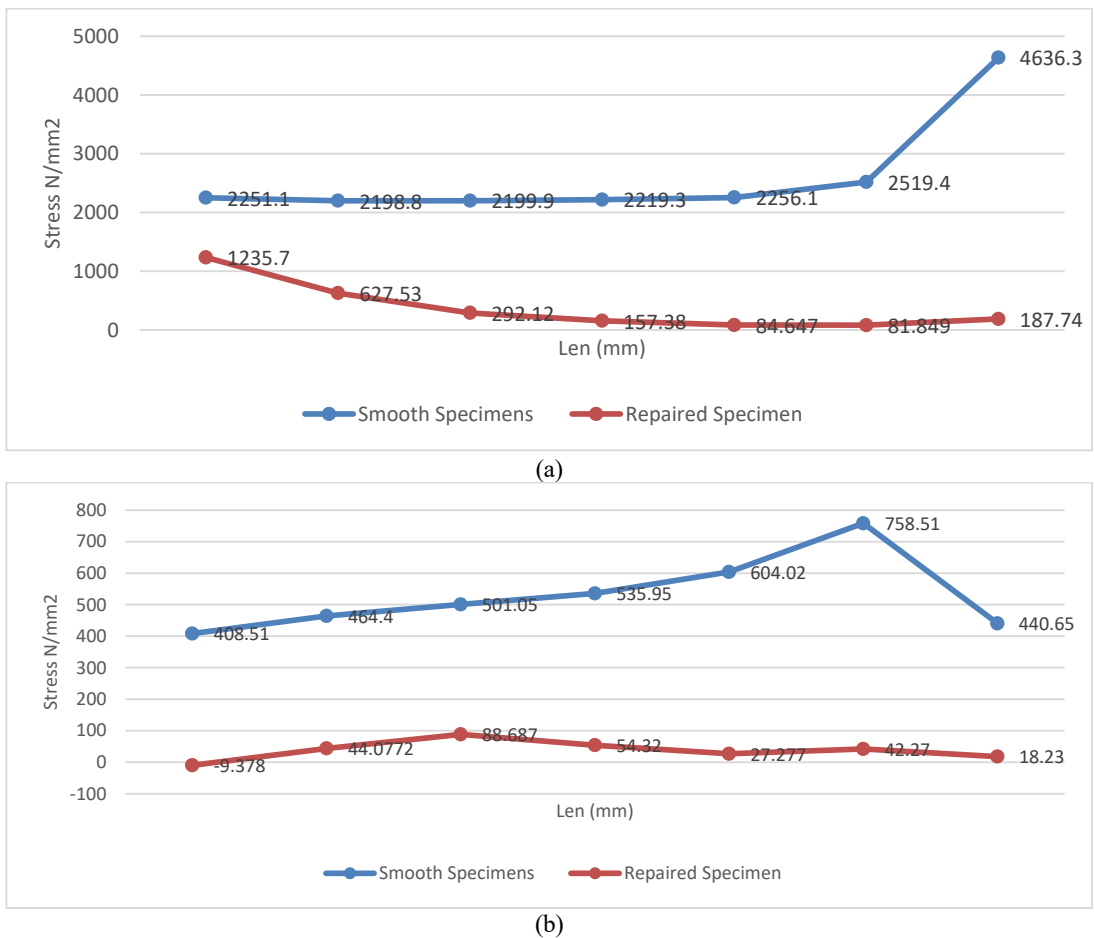
Fig 16. Stress evolution before and after repair from the edge of the plate to the hole (along line L)

The stress evolution along line L (**Fig. 16**) elucidates a substantial decrease in stresses after laminate bonding, particularly at the hole edge where a stress concentration previously existed.
