Footprint of construction errors on the structural damages

The majority of structural failures are attributable to errors in construction. This problem exists in all countries, but it is more frequent in developing communities. This study focuses on construction errors of structures in Tehran, the capital city of Iran. In this study, eighty-eight buildings have been investigated during the construction phase. These buildings have been categorized into ten types and have been distributed in twenty-two suburbs. Results showed that the buildings of Tehran can suffer from at least forty-nine major construction problems. In addition, for the first time, this research has introduced the following three terms in relation to prioritizing of construction errors: Relative Importance Factor (RIF), Priority Index (PI) and Structural Importance Index (SII). As a part of the conclusions, the results showed one hundred percent of investigated buildings are affected dramatically by the “use of untrained workers” and “lack of sampling or wrong sampling” too. In this regard, the RIF and PI of each “Lack of sampling or wrong sampling” and “use of untrained workers” are 100 and 1, respectively. Also,

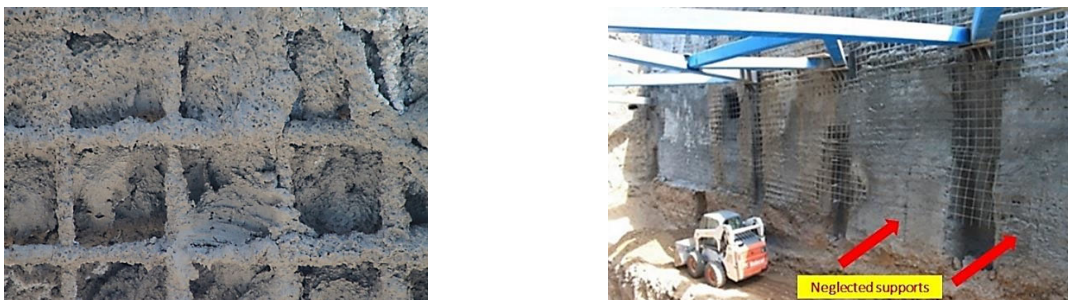
Anyconcrete element regardless of its importance, size and position, must have aproper mix design. However, 80% of steel structures (SS) and 70% of concretestructures (CS) do not have a real and reliable mix design. In these cases, concrete(or even ready-mixed concrete) usually have been made based on traditionalmethods and practices. Also, the concrete is still made often by hand. Theincorrect mixing of concrete components is one of the major problems of suchbuildings. In addition, the concrete casting method in 80% of steel structuresand 70% of concrete structures is wrong. Casting by shovel, discharge by chutefrom high altitude and concrete distributions by vibrator are among some of thecommon errors. On the other hand, in almost all cases, concrete vibration hasbeen associated with some errors such as inadequate vibration, over vibration, inadequatedepth of vibration, duplicate vibration, close vibration, pushing andnon-overlapped vibration. Also, any concrete element needs to be cured by waterin order to complete chemical reactions. However, 42% of concrete elements in concretestructural elements (such as diaphragms) and 95% of whole Concrete buildingshave not been adequately cured. Generally speaking, concrete casting in adverseweather conditions may reduce the concrete strength. However, some arrangementscan be made in order to cast in weather conditions. Surprisingly, in somecases, the concrete casting was done in snowy and sub-zero temperatureconditions. Also, in spite of the importance of conducting concrete tests, inmore than 95% of the studied cases, a reliable concrete test was not carriedout. Because the minimum required number of samples, the sampling method andthe period of sampling were not at all acceptable. Unfortunately, many expectmiraculous behaviour from shotcreting. For this reason, shortcrete-made structuresare not often completed. Insufficient cover, up to down shotting direction andneglected supports are the most common construction errors in investigatedcases (Fig. 2).

Fig. 2. Not completed shotcrete structures

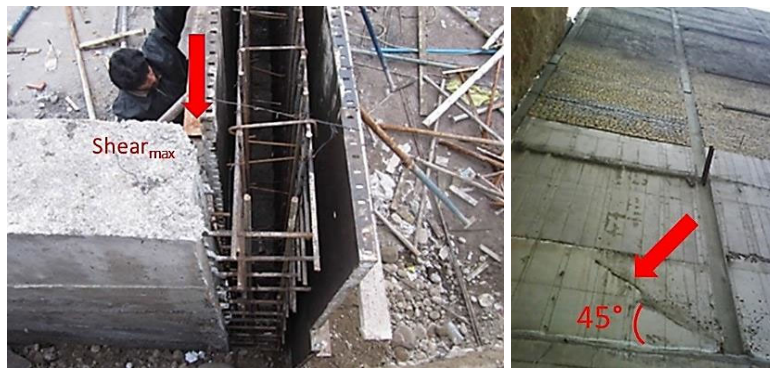
Choosing the right place for construction joints is critical in the strength of resulting concrete elements. Unfortunately, this study showed there is a structural weakness in at least 41% of steel structures and 11% of concrete structures due to unsuitable construction joints (Fig. 3).

Fig. 3. Wrong construction joint position at a concrete wall joint (left) and a shear wall (right)

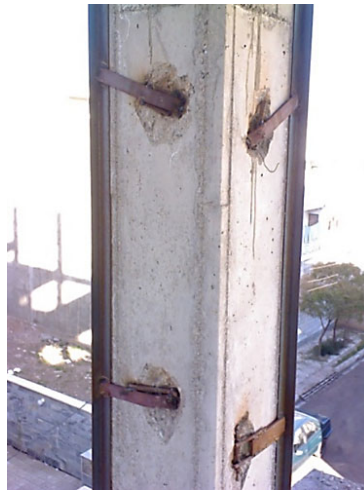
One of the other construction errors in the investigated cases is the localized and partial removal of concrete elements without any permission (Fig. 4).

Fig. 4. Unauthorized concrete tampering and welding some architectural parts to bars

25% of concrete structures in Tehran have this problem. This error can sometimes destroy the integrity of the entire building. Also, in some cases, the required covers specified in the drawings are not provided for reinforcement steels. This error, in addition to corrosion and causing concrete cancer, can reduce the bearing capacity of some parts of the steel bars. On the other hand, construction wastes are not only used instead of spacers but also in 5% to 27% of cases; they are used as fillers in concrete structural elements.

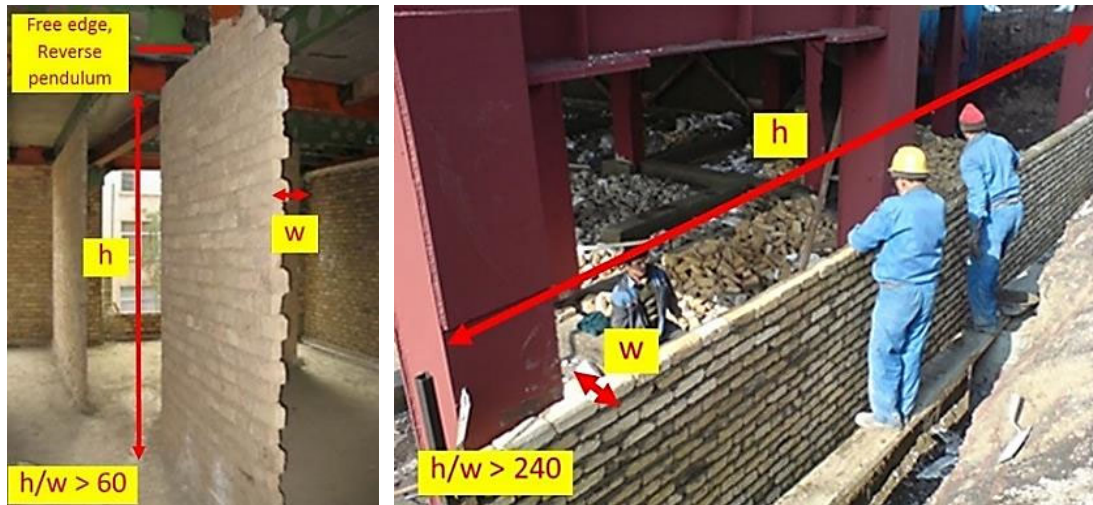
detected in 43% of steel structures and 55% of concrete structures of Tehran. Lack of attention to the structural details of the stairs and lifts is another construction error detected in 34% to 41% of cases. Removing the wall posts of slender walls is another common error (Fig. 5). This error, which occurs in 25% to 36% of buildings, kills many people during earthquakes worldwide.

Fig. 5. Post-less slender walls

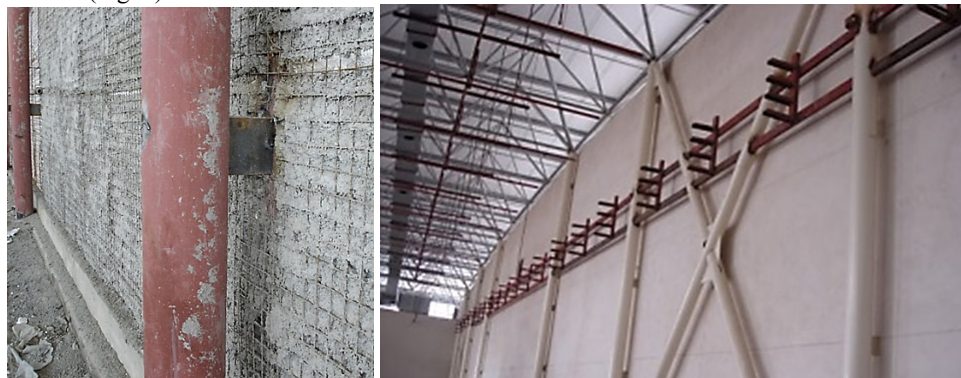
The structural system of façades in 48% of steel structures and 64% of concrete structures is also constructed inadequately. The weak welds and the use of heavy stones without any anchor-screws are among this type of construction errors. One of the errors that is rarely considered is the change of stiffness and slenderness of structural members due to the connection with non-structural elements (Fig. 6).

Fig. 6. Sudden change in the slenderness (left) and punching the columns and braces in order to pass the utility pipes (right)

- A sudden change of stiffness and the possibility of a soft or hard storey in buildings;
- Changing the slenderness and consequently changing the bending axis and changing the three-dimensional behaviour of the structure;
- Local buckling or bearing in thin-walled steel components;
- Disturbance in the behaviour of the lateral bearing systems, such as braces.

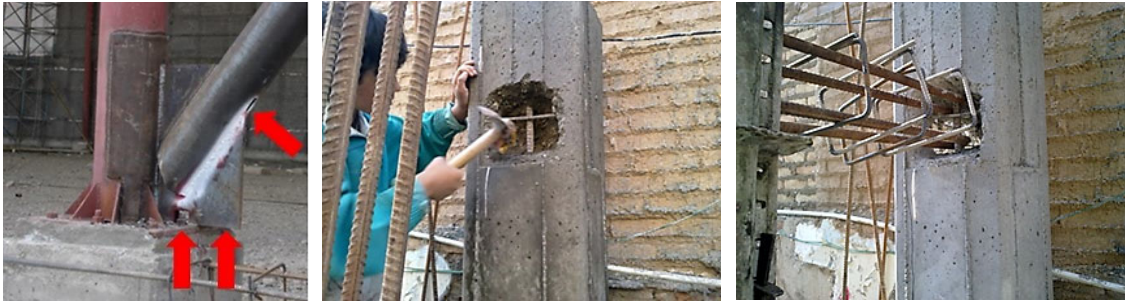
Connections have an essential role in the stability of structures. Regardless of the correct design, proper construction also plays a vital role in the performance of connections. For example, the welded joints of tubular members should be done very carefully. However, the use of undefined or wrong connections is detected in 14% of steel structures and 5% of concrete structures in Tehran (Fig. 7).

Fig. 7. A weak welded connection of tubular members (left) and a wrong concrete connection (middle and right)

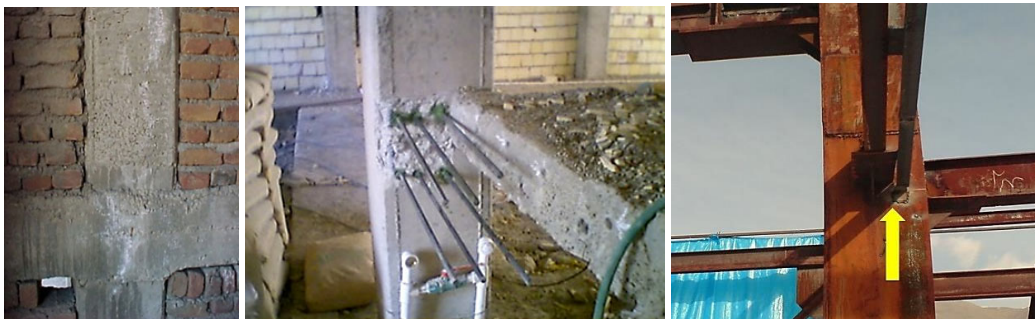
Twisted or non-alignment members and wrong dimensions of elements are two common types of construction errors regarding concrete structures. These errors are found in 43% to 55% of the studied cases. Some examples of these errors can be seen in Fig. 9.

Fig. 9. Some examples for non-alignment columns (left), wrong dimensions of slabs (middle) and wrong position of beams (right)

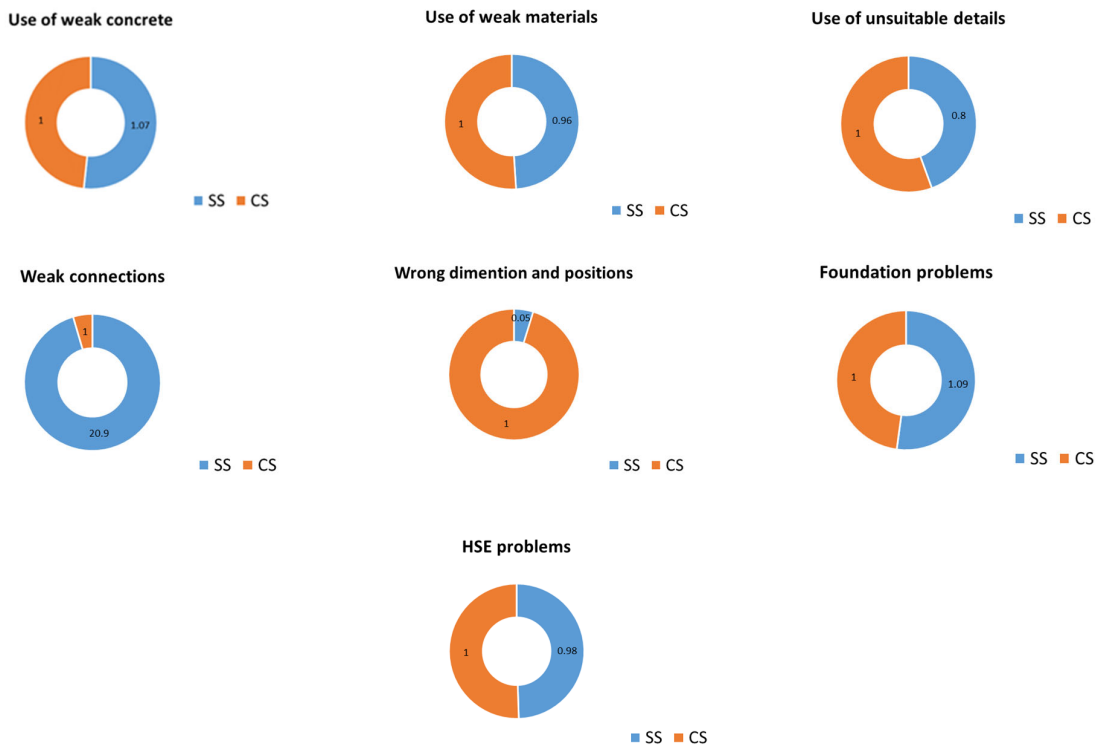
Table 3 shows the Structural Importance Index (SII) of different detected problems in the studied buildings and Fig. 10 shows the related info-graphs.

Fig. 10. Info-graphs of several construction errors in Tehran

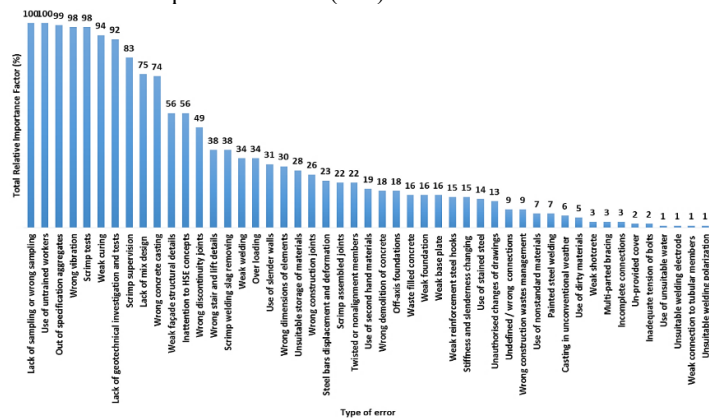
Fig. 11 shows the sorted total relative importance factor (RIF) of several construction errors in Tehran construction sites.

Fig. 11. Total Relative Importance Factor (RIF) of several construction errors in Tehran

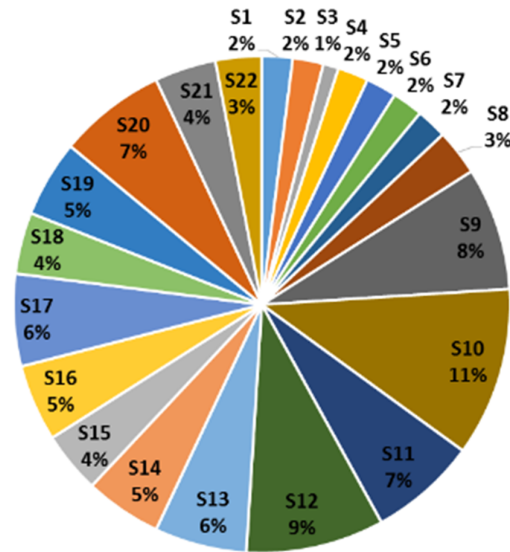
The geographical distribution of construction errors is shown in Fig. 12.

Fig. 12. The distribution of construction errors in Tehran suburbs
